# Unreinforced Masonry Building Seismic Hazards Study

December 2007

City of Seattle Department of Planning and Develpoment

Reid Middleton

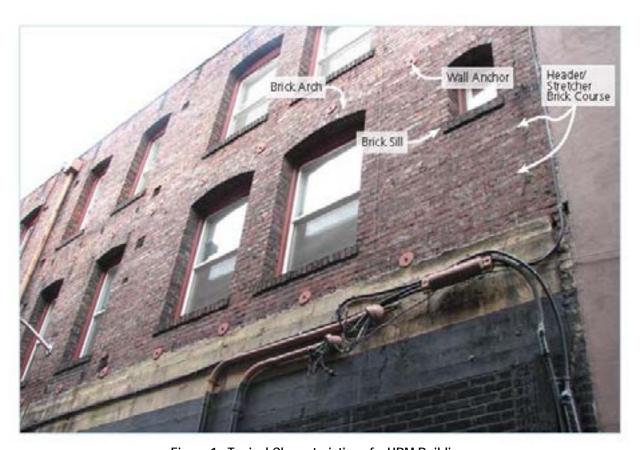
Figure 1. Typical Characteristics of a URM Building.

URM buildings were identified in the field by common characteristics, such as header bricks, brick sills, brick arches, and wall anchors, as shown in Figure 1. Buildings with these features and constructed before 1940 were included in the URM survey. Typically, West Coast building codes prohibited unreinforced masonry building construction after 1940. The year of the building's construction was usually identified through King County's GIS parcel viewer system, which lists tax records and other information about the structure. In some cases, the year was found through the date indicated on the building's cornerstone or through news articles.

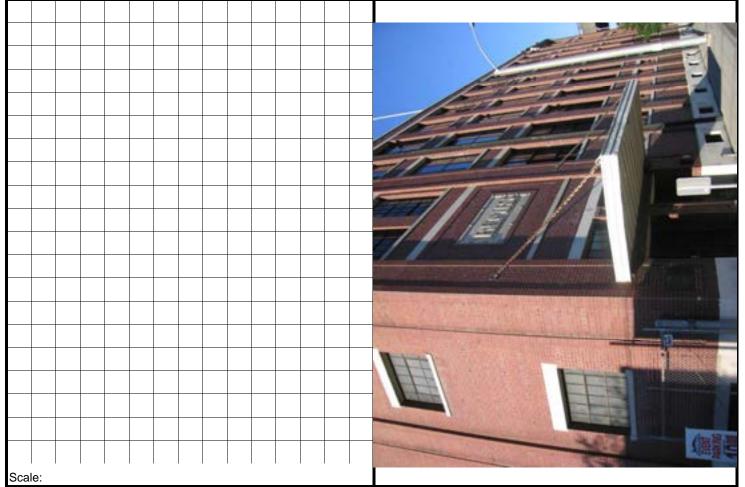
Address	5	5 to 65 S. Atla	antic
District	SoDo	Zip	98134
Other Identifiers	;		
No. Stories	4	Year Built	1904
Inspector	KMB	Date	08.14.07
Total Floor Area	(sq. ft)		30,600
Building Name		Bemis Comp	any Inc.
Use

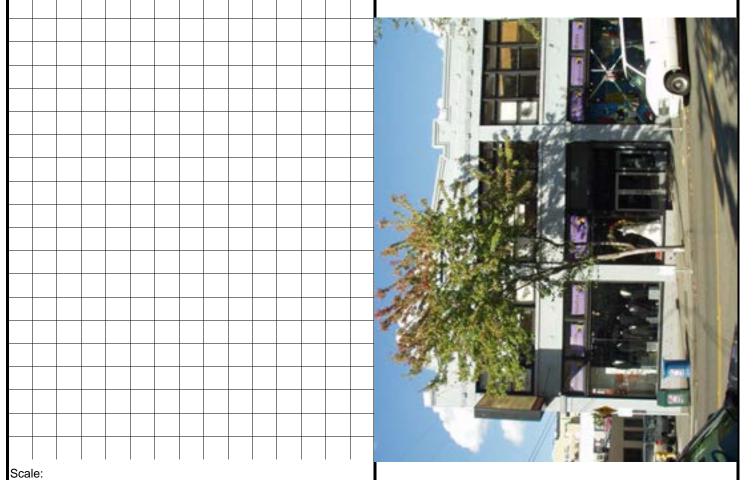
Address		500 E Pike	St
District	Capitol Hill	Zip	98122
Other Identit	fiers	<u></u>	
No. Stories	2	Year Built	1924
Inspector	ADF	 Date	09.28.07
Total Floor A	Area (sq. ft)	2	24,476
Building Nar	me	·	
عوا ا			,

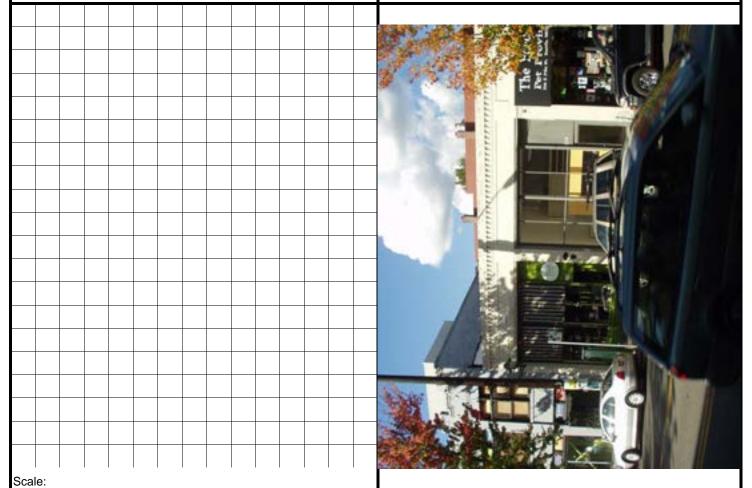
Address	512 to 518 E Pike St										
District	Capitol Hill Zip 98122										
Other Identifiers											
No. Stories	1	Year Built	1926								
Inspector	ADF	Date	09.28.07								
Total Floor Area	(sq. ft)		4,400								
Building Name											
Use	•

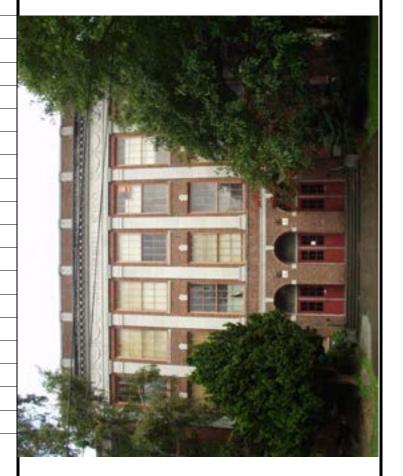
520 NE Ravenna Blvd Address Roosevelt 98115 Zip District Other Identifiers 3 1946 No. Stories Year Built ADF 09.28.07 Inspector Date Total Floor Area (sq. ft) 88,304 John Marshall School Building Name Use

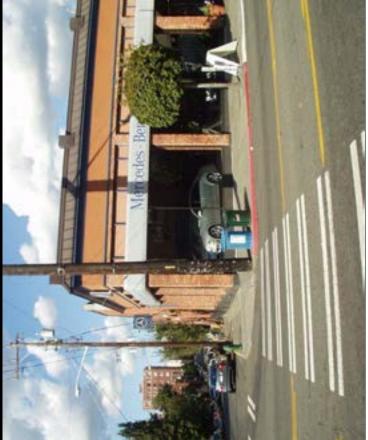
#### 600 E Pike St Reid Middleton Address **Rapid Visual Screening Capitol Hill** Zip District 728 134th Street SW - Suite 200 of Seismically Other Identifiers **Hazardous Buildings** Everett, Washington 98204 No. Stories Year Built ADF Ph: 425 741-3800 Inspector Date **High Seismicity Area** Total Floor Area (sq. ft) Fax: 425 741-3900 Phil Smart Mercedes Building Name Use

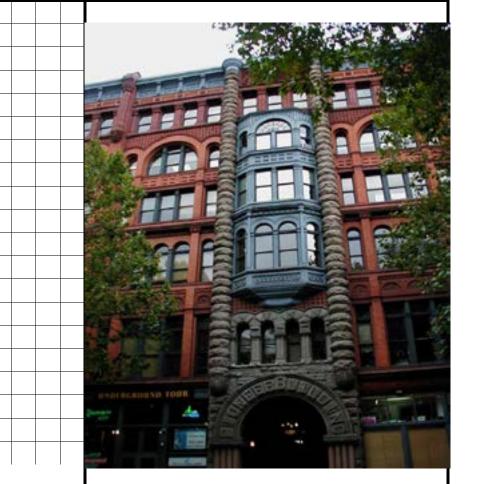
Address	600 to 608 1st Ave								
District	Downtown	Downtown Zip 98104							
Other Identifiers	3	<u> </u>							
No. Stories	6+bsmt	Year Built	1889						
Inspector	ADF	Date	10.03.07						
Total Floor Area	a (sq. ft)	8	9,000						
Building Name	me Pioneer Building								
Use

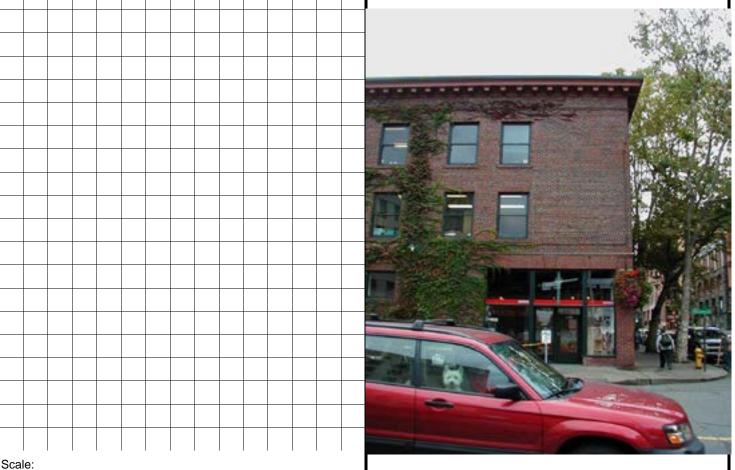
Address	600 Western Ave							
District	Downtown Zip 98104							
Other Identifiers								
No. Stories	3	Year Built	1913					
Inspector	ADF	Date	10.03.07					
Total Floor Area	(sq. ft)	1	9,014					
Building Name								
Use

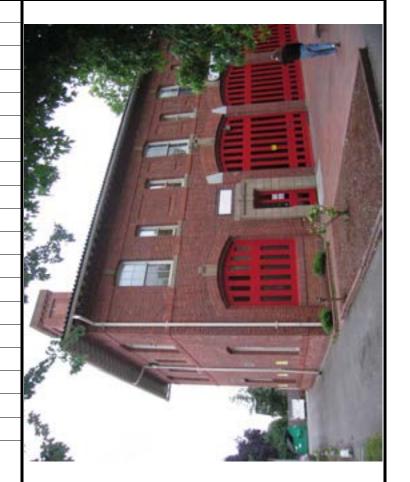
Address	720	to 722 18tl	h Ave						
District	Capitol Hill	Zip	98122						
Other Identifiers									
No. Stories	2	Year Built	1908						
Inspector	KMB	Date	08.10.07						
Total Floor Area	(sq. ft)	17,200							
Building Name Central Area Motivation Program

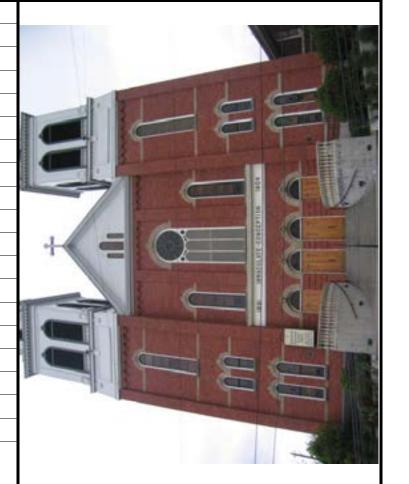
800 18th Ave Address **Capitol Hill** 98122 District Zip Other Identifiers 1901 1+bsmt No. Stories Year Built 08.10.07 **KMB** Inspector Date Total Floor Area (sq. ft) 26,500 **Immaculate Conception** Building Name Use

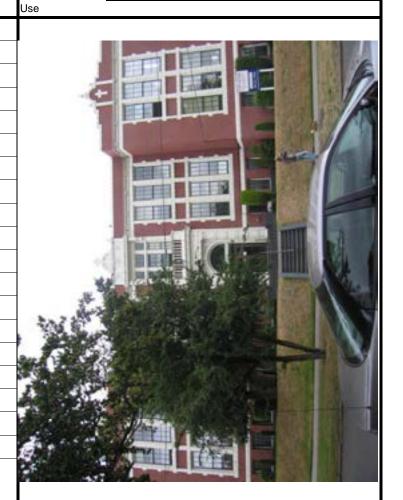
810 18th Ave Address **Capitol Hill** 98122 District Zip Other Identifiers 2+bsmt 1904 No. Stories Year Built 08.10.07 **KMB** Inspector Date Total Floor Area (sq. ft) 17,500 **Immaculate Conception School** Building Name

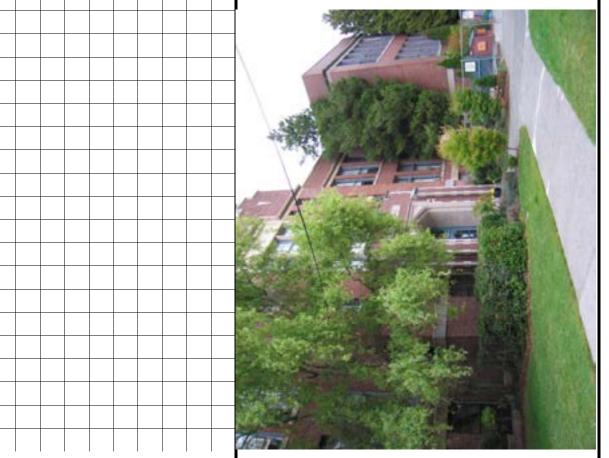
Address	8	44 NE 78th	St
District	University	Zip	98115
Other Identifiers			
No. Stories	3	Year Built	1908
Inspector	KMB	Date	09.20.07
Total Floor Area	(sq. ft)	4	5,680
Building Name	TI	he Fairview	Church
Use

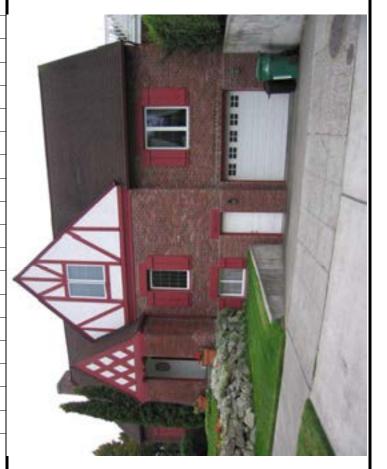
Address	8	355 NE 83rd	St
District	University	Zip	98115
Other Identifiers			
No. Stories	2+	Year Built	1929
Inspector	KMB	Date	09.20.07
Total Floor Area	(sq. ft)		1,350
Building Name			
l lea	R	esidential

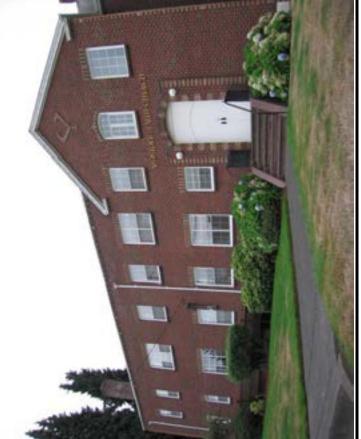
Address		901 NE 75t	h
District	University	Zip	98115
Other Identifiers	S		
No. Stories	2+	Year Built	1907
Inspector	KMB	_ Date	09.20.07
Total Floor Area	a (sq. ft)	1	2,256
Building Name	Ap	ostolic Fait	h Church
Use

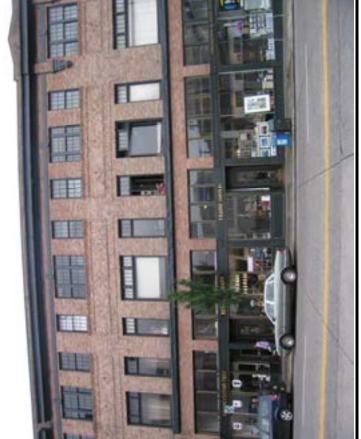
901 to 911 E Pike St Address **Capitol Hill** 98122 Zip District Other Identifiers 3 1912 No. Stories Year Built KMB 08.03.07 Inspector Date Total Floor Area (sq. ft) 30,000 Broadway & E Pike Building Name Use

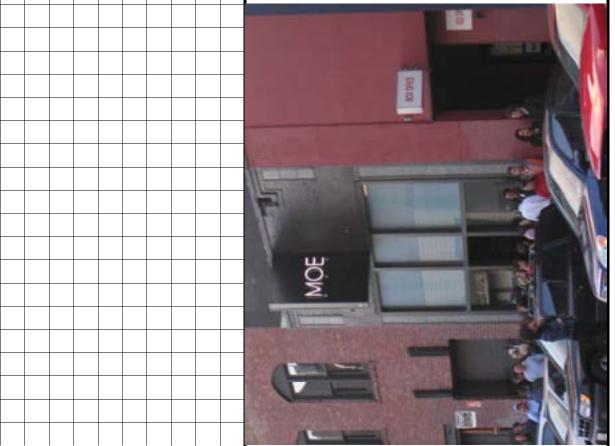
Address	!	925 E Pike	St
District	Capitol Hill	Zip	98122
Other Identifie	rs		
No. Stories	1	Year Built	1916
Inspector	KMB	Date	08.09.07
Total Floor Are	ea (sq. ft)	1	5,164
Building Name		Moe B	ar
Use

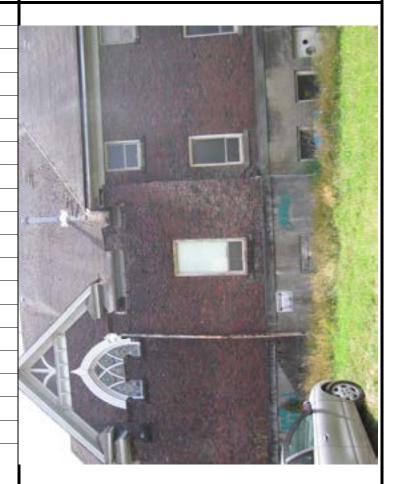
1103 14th Ave Address **Capitol Hill** 98102 District Zip Other Identifiers 1907 1 No. Stories Year Built **KMB** 08.03.07 Inspector Date Total Floor Area (sq. ft) 11,346 **Progressive Missionary Baptist Church** Building Name

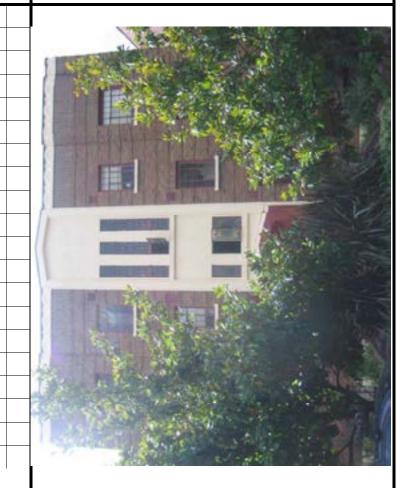
Address	1	1115 17th A	ve
District	Capitol Hill	Zip	98122
Other Identifiers	s		
No. Stories	3+bsmt	Year Built	1929
Inspector	KMB	Date	08.09.07
Total Floor Area	a (sq. ft)	1	11,136
Building Name		Martha A	nne
Use		•

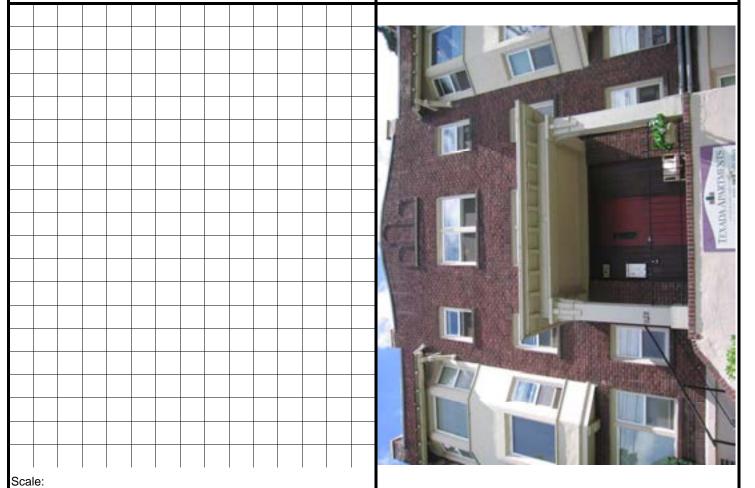
Address	1	128 13th A	ve
District	Capitol Hill	Zip	98122
Other Identifiers	3		
No. Stories	3	Year Built	1923
Inspector	KMB	Date	08.03.07
Total Floor Area	a (sq. ft)	1	8,758
Building Name	T	exada Apa	rtments
Use		-

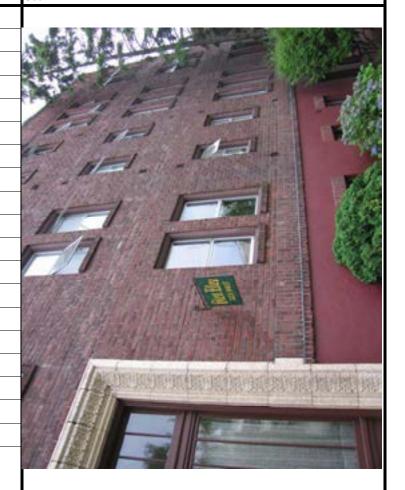
1305 E Denny Way Address **Capitol Hill** 98122 Zip District Other Identifiers 3+bsmt 1922 No. Stories Year Built 08.09.07 **KMB** Inspector Date Total Floor Area (sq. ft) 19,680 Glen Ellen Building Name Use

OCCU	PANCY	STR	UCTU	RAL	SCO	RES	AND	MO	DIFIE	RS				
* Residential	No. Persons:	BUILDING TYPE	W	S1	S2	S3	S4	C1	C2	C3/S5	PC1	PC2	RM	URM
Commercial	0-10	Basic Score	4.5	4.5	3.0	5.5	3.5	2.0	3.0	1.5	2.0	1.5	3.0	1.0
Office	* <mark>11-100</mark>	High Rise	N/A	-2.0	-1.0	N/A	-1.0	-1.0	-1.0	-0.5	N/A	-0.5	-1.0	-0.5
Industrial	100+	Poor Condition	-0.5	-0.5	-0.5	-0.5	-0.5	-0.5	-0.5	-0.5	-0.5	-0.5	-0.5	-0.5
Pub. Assem.		Vert. Irregularity	-0.5	-0.5	-0.5	-0.5	-0.5	-1.0	-0.5	-0.5	-1.0	-1.0	-0.5	-0.5
School		Soft Story	-1.0	-2.5	-2.0	-1.0	-2.0	-2.0	-2.0	-1.0	-1.0	-2.0	-2.0	-1.0
Govt. Bldg.		Torsion	-1.0	-2.0	-1.0	-1.0	-1.0	-1.0	-1.0	-1.0	-1.0	-1.0	-1.0	-1.0
Emer. Serv.		Plan Irregularity	-1.0	-0.5	-0.5	-0.5	-0.5	-0.5	-0.5	-0.5	-1.0	-1.0	-1.0	-1.0
Historic Bldg.		Pounding	N/A	-0.5	-0.5	N/A	-0.5	-0.5	N/A	N/A	N/A	-0.5	N/A	N/A
Nonstructura	al	Large Heavy Cladding	N/A	-2.0	N/A	N/A	N/A	-1.0	N/A	N/A	N/A	-1.0	N/A	N/A
Falling Haza	ard X	Short Columns	N/A	N/A	N/A	N/A	N/A	-1.0	-1.0	-1.0	N/A	-1.0	N/A	N/A

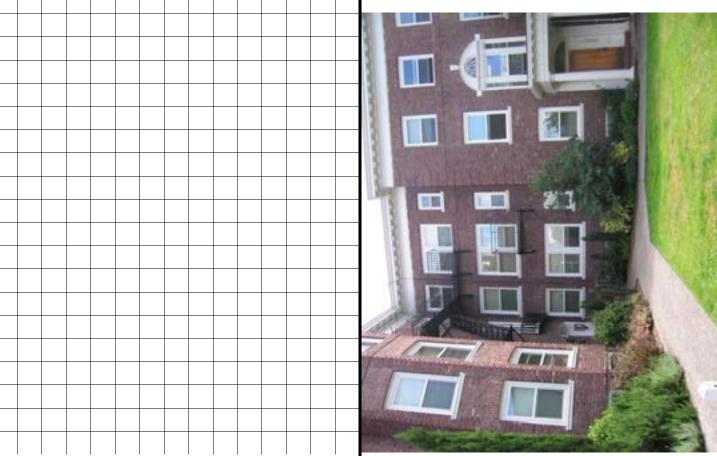
Address	1;	319 E Unior	n St
District	Capitol Hill	Zip	98122
Other Identifiers	;		
No. Stories	3	Year Built	1909
Inspector	KMB	Date	08.03.07
Total Floor Area	ı (sq. ft)	2	4,316
Building Name	Н	elen V Apa	rtments
Use

OCCUI	PANCY	STR	UCTU	RAL	SCO	RES	AND	MO	DIFIE	ERS				
* Residential	No. Persons:	BUILDING TYPE	W	<u>S1</u>	<u>S2</u>	<u>S3</u>	<u>S4</u>	<u>C1</u>	<u>C2</u>	C3/S5	PC1	PC2	<u>RM</u>	<u>URM</u>
Commercial	0-10	Basic Score	4.5	4.5	3.0	5.5	3.5	2.0	3.0	1.5	2.0	1.5	3.0	1.0
Office	11-100	High Rise	N/A	-2.0	-1.0	N/A	-1.0	-1.0	-1.0	-0.5	N/A	-0.5	-1.0	-0.5
Industrial	* <mark>100+</mark>	Poor Condition	-0.5	-0.5	-0.5	-0.5	-0.5	-0.5	-0.5	-0.5	-0.5	-0.5	-0.5	-0.5
Pub. Assem.		Vert. Irregularity	-0.5	-0.5	-0.5	-0.5	-0.5	-1.0	-0.5	-0.5	-1.0	-1.0	-0.5	-0.5
School		Soft Story	-1.0	-2.5	-2.0	-1.0	-2.0	-2.0	-2.0	-1.0	-1.0	-2.0	-2.0	-1.0
Govt. Bldg.		Torsion	-1.0	-2.0	-1.0	-1.0	-1.0	-1.0	-1.0	-1.0	-1.0	-1.0	-1.0	-1.0
Emer. Serv.		Plan Irregularity	-1.0	-0.5	-0.5	-0.5	-0.5	-0.5	-0.5	-0.5	-1.0	-1.0	-1.0	-1.0
Historic Bldg.		Pounding	N/A	-0.5	-0.5	N/A	-0.5	-0.5	N/A	N/A	N/A	-0.5	N/A	N/A
Nonstructura	al	Large Heavy Cladding	N/A	-2.0	N/A	N/A	N/A	-1.0	N/A	N/A	N/A	-1.0	N/A	N/A

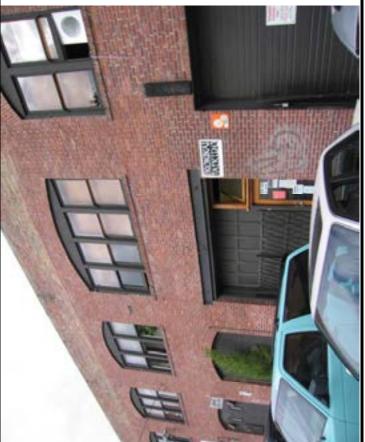
Address	1415	to 1423 10	th Ave
District	Capitol Hill	Zip	98122
Other Identifiers	3		
No. Stories	2	Year Built	1907
Inspector	KMB	Date	08.09.07
Total Floor Area	a (sq. ft)	3	6,000
Building Name		Red Sky S	Studio
Use		•

PANCY	STR	UCTU	RAL	SCO	RES	AND	MO	DIFIE	ERS				
No. Persons:	BUILDING TYPE	W	<u>S1</u>	<u>S2</u>	<u>S3</u>	<u>S4</u>	<u>C1</u>	<u>C2</u>	C3/S5	PC1	PC2	<u>RM</u>	<u>URM</u>
0-10	Basic Score	4.5	4.5	3.0	5.5	3.5	2.0	3.0	1.5	2.0	1.5	3.0	1.0

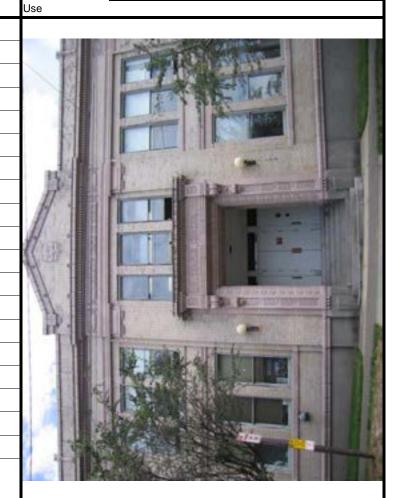
1424 15th Ave Address **Capitol Hill** Zip 98122 District Other Identifiers 2+bsmt 1900 No. Stories Year Built 08.09.07 **KMB** Inspector Date Total Floor Area (sq. ft) 16,032 Temple Center Building Name

outo.													
OCCU	PANCY	STR	UCTU	RAL	sco	RES	AND	) MO	DIFIE	ERS				
Residential	No. Persons:	BUILDING TYPE	W	<u>S1</u>	<u>S2</u>	<u>S3</u>	<u>S4</u>	<u>C1</u>	<u>C2</u>	C3/S5	PC1	PC2	RM	<u>URM</u>
Commercial	0-10	Basic Score	4.5	4.5	3.0	5.5	3.5	2.0	3.0	1.5	2.0	1.5	3.0	1.0
Office	11-100	High Rise	N/A	-2.0	-1.0	N/A	-1.0	-1.0	-1.0	-0.5	N/A	-0.5	-1.0	-0.5
Industrial	* <mark>100+</mark>	Poor Condition	-0.5	-0.5	-0.5	-0.5	-0.5	-0.5	-0.5	-0.5	-0.5	-0.5	-0.5	-0.5
Pub. Assem.		Vert. Irregularity	-0.5	-0.5	-0.5	-0.5	-0.5	-1.0	-0.5	-0.5	-1.0	-1.0	-0.5	-0.5

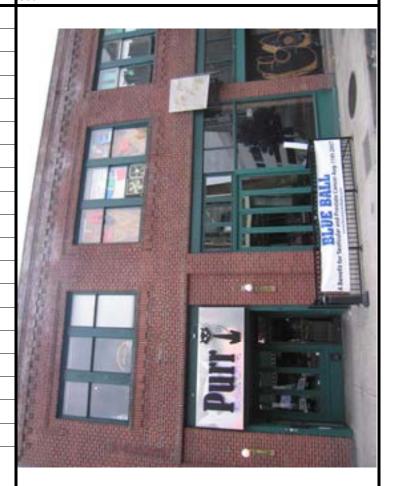
1518 to 1520 11th Ave Address Capitol Hill Zip 98122 District Other Identifiers 2 1915 No. Stories Year Built **KMB** 08.09.07 Inspector Date Total Floor Area (sq. ft) 21,600 **Purr Cocktail Lounge** Building Name Use

Evaluation Required?
YES

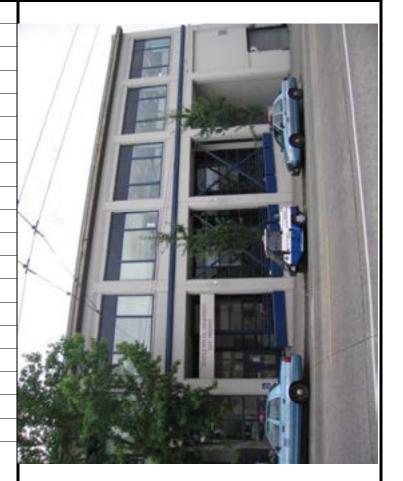
Address	1	1519 12th A	ve
District	Capitol Hill	Zip	98122
Other Identifiers			
No. Stories	2+bsmt	Year Built	1926
Inspector	KMB	Date	08.09.07
Total Floor Area	(sq. ft)		61,580
Building Name	Seattle	Police Dep	partment East

OCCUI	PANCY	STRUCTURAL SCORES AND MODIFIERS												
Residential	No. Persons:	BUILDING TYPE	W	<u>S1</u>	<u>S2</u>	<u>S3</u>	<u>S4</u>	<u>C1</u>	<u>C2</u>	C3/S5	PC1	PC2	RM	<u>URM</u>
Commercial	0-10	Basic Score	4.5	4.5	3.0	5.5	3.5	2.0	3.0	1.5	2.0	1.5	3.0	1.0
Office	11-100	High Rise	N/A	-2.0	-1.0	N/A	-1.0	-1.0	-1.0	-0.5	N/A	-0.5	-1.0	-0.5
Industrial	* <mark>100+</mark>	Poor Condition	-0.5	-0.5	-0.5	-0.5	-0.5	-0.5	-0.5	-0.5	-0.5	-0.5	-0.5	-0.5
Pub. Assem.		Vert. Irregularity	-0.5	-0.5	-0.5	-0.5	-0.5	-1.0	-0.5	-0.5	-1.0	-1.0	-0.5	-0.5
School		Soft Story	-1.0	-2.5	-2.0	-1.0	-2.0	-2.0	-2.0	-1.0	-1.0	-2.0	-2.0	-1.0

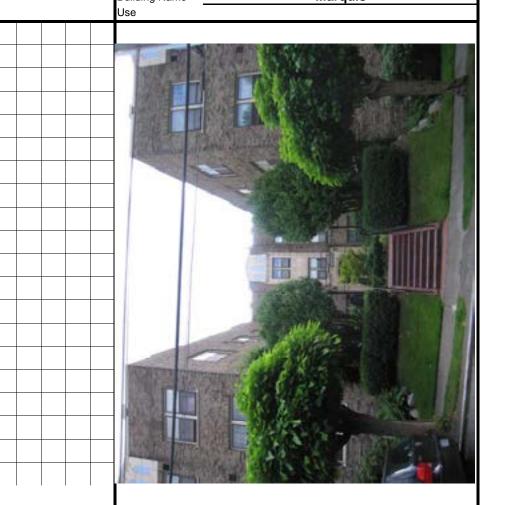
Address	16	05 E Howe	II St
District	Capitol Hill	Zip	98122
Other Identifiers	3		
No. Stories	3+bsmt	Year Built	
Inspector	KMB	Date	08.09.07
Total Floor Area	a (sq. ft)		
Building Name		Margu	is

O O O U DANIOY		<del>. !</del> .											
OCCU	PANCY	STR	UCTU	RAL	SCO	RES	AND	MO	DIFIE	ERS				
* Residential	No. Persons:	BUILDING TYPE	W	<u>S1</u>	<u>S2</u>	<u>S3</u>	<u>S4</u>	<u>C1</u>	<u>C2</u>	C3/S5	PC1	PC2	<u>RM</u>	<u>URM</u>
Commercial	0-10	Basic Score	4.5	4.5	3.0	5.5	3.5	2.0	3.0	1.5	2.0	1.5	3.0	1.0
Office	11-100	High Rise	N/A	-2.0	-1.0	N/A	-1.0	-1.0	-1.0	-0.5	N/A	-0.5	-1.0	-0.5
Industrial	* <mark>100+</mark>	Poor Condition	-0.5	-0.5	-0.5	-0.5	-0.5	-0.5	-0.5	-0.5	-0.5	-0.5	-0.5	-0.5
Pub. Assem.		Vert. Irregularity	-0.5	-0.5	-0.5	-0.5	-0.5	-1.0	-0.5	-0.5	-1.0	-1.0	-0.5	-0.5
School		Soft Story	-1.0	-2.5	-2.0	-1.0	-2.0	-2.0	-2.0	-1.0	-1.0	-2.0	-2.0	-1.0
Govt. Bldg.		Torsion	-1.0	-2.0	-1.0	-1.0	-1.0	-1.0	-1.0	-1.0	-1.0	-1.0	-1.0	-1.0
Emer. Serv.		Plan Irregularity	-1.0	-0.5	-0.5	-0.5	-0.5	-0.5	-0.5	-0.5	-1.0	-1.0	-1.0	-1.0
Historic Bldg.		Pounding	N/A	-0.5	-0.5	N/A	-0.5	-0.5	N/A	N/A	N/A	-0.5	N/A	N/A

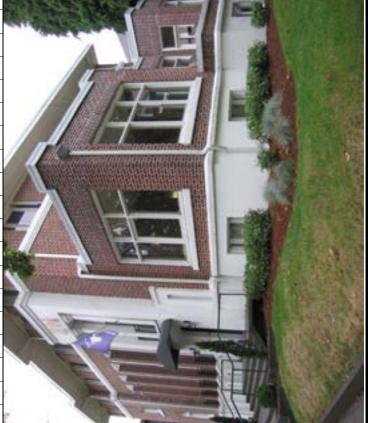
#### Reid Middleton 1616 NE 47th St Address **Rapid Visual Screening** University 98105 District Zip 728 134th Street SW - Suite 200 of Seismically Other Identifiers **Hazardous Buildings** 2 1916 Everett, Washington 98204 No. Stories Year Built 09.20.07 **KMB** Ph: 425 741-3800 Inspector Date **High Seismicity Area** Total Floor Area (sq. ft) 16,382 Fax: 425 741-3900 Gamma Chi Building Name Use

OCCUI	PANCY	STR	UCTU	RAL	SCO	RES	AND	MOI	DIFIE	RS				
* Residential	No. Persons:	BUILDING TYPE	W	<u>S1</u>	<u>S2</u>	<u>S3</u>	<u>S4</u>	<u>C1</u>	<u>C2</u>	C3/S5	PC1	PC2	<u>RM</u>	<u>URM</u>
Commercial	0-10	Basic Score	4.5	4.5	3.0	5.5	3.5	2.0	3.0	1.5	2.0	1.5	3.0	1.0
Office	11-100	High Rise	N/A	-2.0	-1.0	N/A	-1.0	-1.0	-1.0	-0.5	N/A	-0.5	-1.0	-0.5
Industrial	100+	Poor Condition	-0.5	-0.5	-0.5	-0.5	-0.5	-0.5	-0.5	-0.5	-0.5	-0.5	-0.5	-0.5
Pub. Assem.		Vert. Irregularity	-0.5	-0.5	-0.5	-0.5	-0.5	-1.0	-0.5	-0.5	-1.0	-1.0	-0.5	-0.5
School		Soft Story	-1.0	-2.5	-2.0	-1.0	-2.0	-2.0	-2.0	-1.0	-1.0	-2.0	-2.0	-1.0
Govt. Bldg.		Torsion	-1.0	-2.0	-1.0	-1.0	-1.0	-1.0	-1.0	-1.0	-1.0	-1.0	-1.0	-1.0
Emer. Serv.		Plan Irregularity	-1.0	-0.5	-0.5	-0.5	-0.5	-0.5	-0.5	-0.5	-1.0	-1.0	-1.0	-1.0
Historic Bldg.		Pounding	N/A	-0.5	-0.5	N/A	-0.5	-0.5	N/A	N/A	N/A	-0.5	N/A	N/A
Nonstructura	al	Large Heavy Cladding	N/A	-2.0	N/A	N/A	N/A	-1.0	N/A	N/A	N/A	-1.0	N/A	N/A

Falling Hazard		Short Columns	N/A	N/A	N/A	N/A	N/A	-1.0	-1.0	-1.0	N/A	-1.0	N/A	N/A
		Post Benchmark Year	2.0	2.0	2.0	2.0	2.0	2.0	2.0	N/A	2.0	2.0	2.0	N/A
DATA CON	FIDENCE	SL2	-0.3	-0.3	-0.3	-0.3	-0.3	-0.3	-0.3	-0.3	-0.3	-0.3	-0.3	-0.3

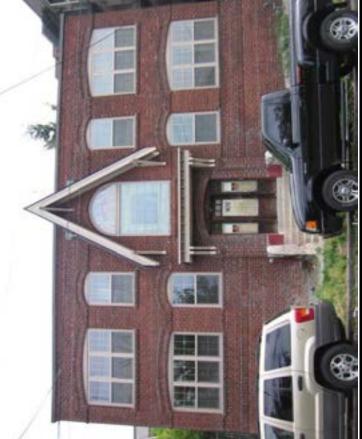
Address	1	1620 14th A	ve
District	Capitol Hill	Zip	98122
Other Identifiers	;		
No. Stories	2	Year Built	1919
Inspector	KMB	Date	08.09.07
Total Floor Area	a (sq. ft)	1	0,482
Building Name		Del Mar	co
Lleα

OCCUI	PANCY	STR	UCTU	RAL	SCO	RES	AND	MO	DIFIE	RS		STRUCTURAL SCORES AND MODIFIERS												
* Residential	No. Persons:	BUILDING TYPE	W	<u>S1</u>	<u>S2</u>	<u>S3</u>	<u>S4</u>	<u>C1</u>	<u>C2</u>	C3/S5	PC1	PC2	<u>RM</u>	<u>URM</u>										
Commercial	0-10	Basic Score	4.5	4.5	3.0	5.5	3.5	2.0	3.0	1.5	2.0	1.5	3.0	1.0										
Office	* <mark>11-100</mark>	High Rise	N/A	-2.0	-1.0	N/A	-1.0	-1.0	-1.0	-0.5	N/A	-0.5	-1.0	-0.5										
Industrial	100+	Poor Condition	-0.5	-0.5	-0.5	-0.5	-0.5	-0.5	-0.5	-0.5	-0.5	-0.5	-0.5	-0.5										
Pub. Assem.		Vert. Irregularity	-0.5	-0.5	-0.5	-0.5	-0.5	-1.0	-0.5	-0.5	-1.0	-1.0	-0.5	-0.5										
School		Soft Story	-1.0	-2.5	-2.0	-1.0	-2.0	-2.0	-2.0	-1.0	-1.0	-2.0	-2.0	-1.0										
Govt. Bldg.		Torsion	-1.0	-2.0	-1.0	-1.0	-1.0	-1.0	-1.0	-1.0	-1.0	-1.0	-1.0	-1.0										
Emer. Serv.		Plan Irregularity	-1.0	-0.5	-0.5	-0.5	-0.5	-0.5	-0.5	-0.5	-1.0	-1.0	-1.0	-1.0

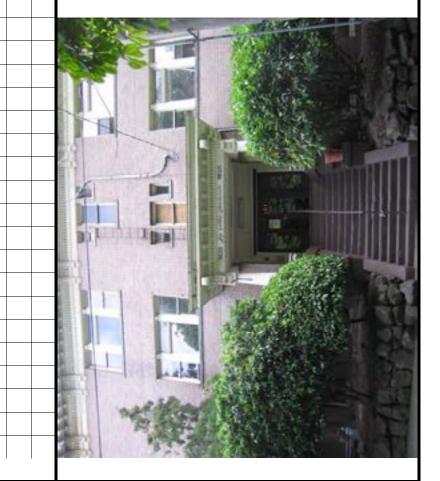
1620 to 1626 13th Ave Address **Capitol Hill** Zip 98122 District Other Identifiers 3+bsmt 1908 No. Stories Year Built 08.09.07 **KMB** Inspector Date Total Floor Area (sq. ft) 17,504 La Villa Apartments Building Name Use

OCCU	PANCY	STRUCTURAL SCORES AND MODIFIERS												
* Residential	No. Persons:	BUILDING TYPE	W	<u>S1</u>	<u>S2</u>	<u>S3</u>	<u>S4</u>	<u>C1</u>	<u>C2</u>	C3/S5	PC1	PC2	<u>RM</u>	<u>URM</u>
Commercial	0-10	Basic Score	4.5	4.5	3.0	5.5	3.5	2.0	3.0	1.5	2.0	1.5	3.0	1.0
Office	11-100	High Rise	N/A	-2.0	-1.0	N/A	-1.0	-1.0	-1.0	-0.5	N/A	-0.5	-1.0	-0.5
Industrial	* <mark>100+</mark>	Poor Condition	-0.5	-0.5	-0.5	-0.5	-0.5	-0.5	-0.5	-0.5	-0.5	-0.5	-0.5	-0.5
Pub. Assem.		Vert. Irregularity	-0.5	-0.5	-0.5	-0.5	-0.5	-1.0	-0.5	-0.5	-1.0	-1.0	-0.5	-0.5
School		Soft Story	-1.0	-2.5	-2.0	-1.0	-2.0	-2.0	-2.0	-1.0	-1.0	-2.0	-2.0	-1.0
Govt. Bldg.		Torsion	-1.0	-2.0	-1.0	-1.0	-1.0	-1.0	-1.0	-1.0	-1.0	-1.0	-1.0	-1.0
Emer. Serv.		Plan Irregularity	-1.0	-0.5	-0.5	-0.5	-0.5	-0.5	-0.5	-0.5	-1.0	-1.0	-1.0	-1.0
Historic Bldg.		Pounding	N/A	-0.5	-0.5	N/A	-0.5	-0.5	N/A	N/A	N/A	-0.5	N/A	N/A
Nonstructur	al	Large Heavy Cladding	N/A	-2.0	N/A	N/A	N/A	-1.0	N/A	N/A	N/A	-1.0	N/A	N/A

Falling Haza	ard X	Short Columns	N/A	N/A	N/A	N/A	N/A	-1.0	-1.0	-1.0	N/A	-1.0	N/A	N/A
		Post Benchmark Year	2.0	2.0	2.0	2.0	2.0	2.0	2.0	N/A	2.0	2.0	2.0	N/A
DATA CON	FIDENCE	SL2	-0.3	-0.3	-0.3	-0.3	-0.3	-0.3	-0.3	-0.3	-0.3	-0.3	-0.3	-0.3

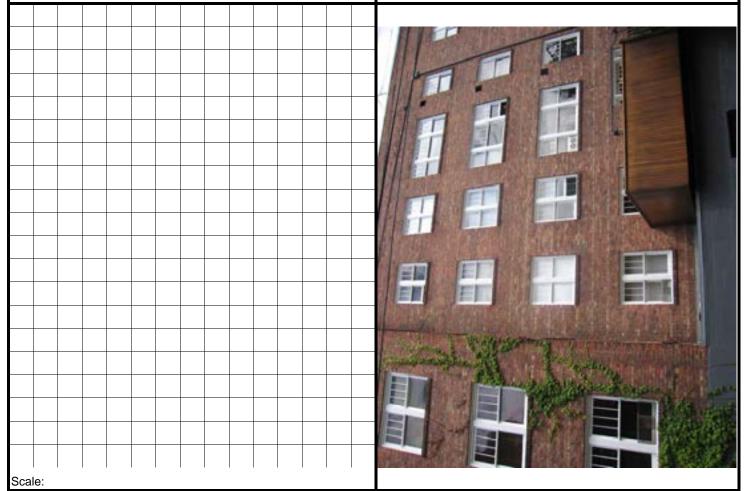
Address	1631 16th Ave											
District	Capitol Hill	Zip	98122									
Other Identif	fiers											
No. Stories	4+bsmt	Year Built	1929									
Inspector	KMB	Date	08.09.07									
Total Floor A	Area (sq. ft)	4	18,840									
Building Nar	me Garden Court											
Use

OCCUI	PANCY	STRUCTURAL SCORES AND MODIFIERS												
* Residential	No. Persons:	BUILDING TYPE	W	<u>S1</u>	<u>S2</u>	<u>S3</u>	<u>S4</u>	<u>C1</u>	<u>C2</u>	C3/S5	PC1	PC2	RM	<u>URM</u>
Commercial	0-10	Basic Score	4.5	4.5	3.0	5.5	3.5	2.0	3.0	1.5	2.0	1.5	3.0	1.0
Office	11-100	High Rise	N/A	-2.0	-1.0	N/A	-1.0	-1.0	-1.0	-0.5	N/A	-0.5	-1.0	-0.5
Industrial	* <mark>100+</mark>	Poor Condition	-0.5	-0.5	-0.5	-0.5	-0.5	-0.5	-0.5	-0.5	-0.5	-0.5	-0.5	-0.5
Pub. Assem.		Vert. Irregularity	-0.5	-0.5	-0.5	-0.5	-0.5	-1.0	-0.5	-0.5	-1.0	-1.0	-0.5	-0.5
School		Soft Story	-1.0	-2.5	-2.0	-1.0	-2.0	-2.0	-2.0	-1.0	-1.0	-2.0	-2.0	-1.0
Govt. Bldg.		Torsion	-1.0	-2.0	-1.0	-1.0	-1.0	-1.0	-1.0	-1.0	-1.0	-1.0	-1.0	-1.0
Emer. Serv.		Plan Irregularity	-1.0	-0.5	-0.5	-0.5	-0.5	-0.5	-0.5	-0.5	-1.0	-1.0	-1.0	-1.0
Historic Bldg.		Pounding	N/A	-0.5	-0.5	N/A	-0.5	-0.5	N/A	N/A	N/A	-0.5	N/A	N/A
Nonstructura	al	Large Heavy Cladding	N/A	-2.0	N/A	N/A	N/A	-1.0	N/A	N/A	N/A	-1.0	N/A	N/A

Falling Haza	ard	Short Columns	N/A	N/A	N/A	N/A	N/A	-1.0	-1.0	-1.0	N/A	-1.0	N/A	N/A
		Post Benchmark Year	2.0	2.0	2.0	2.0	2.0	2.0	2.0	N/A	2.0	2.0	2.0	N/A
DATA CON	FIDENCE	SL2	-0.3	-0.3	-0.3	-0.3	-0.3	-0.3	-0.3	-0.3	-0.3	-0.3	-0.3	-0.3

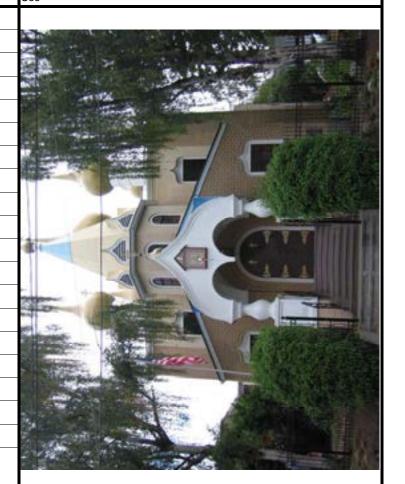
Address	1	1714 13th A	ve
District	Capitol Hill	Zip	98122
Other Identifiers			
No. Stories	1	Year Built	1938
Inspector	KMB	Date	08.09.07
Total Floor Area	(sq. ft)		1,756
Building Name	Russian O	rthodox Me	morial Cathedral
Use

OCCUI	PANCY	STR	UCTU	RAL	SCO	RES	AND	MO	DIFIE	RS				
Residential	No. Persons:	BUILDING TYPE	W	<u>S1</u>	<u>S2</u>	<u>S3</u>	<u>S4</u>	<u>C1</u>	<u>C2</u>	C3/S5	PC1	PC2	<u>RM</u>	<u>URM</u>
Commercial	0-10	Basic Score	4.5	4.5	3.0	5.5	3.5	2.0	3.0	1.5	2.0	1.5	3.0	1.0
Office	* <mark>11-100</mark>	High Rise	N/A	-2.0	-1.0	N/A	-1.0	-1.0	-1.0	-0.5	N/A	-0.5	-1.0	-0.5
Industrial	100+	Poor Condition	-0.5	-0.5	-0.5	-0.5	-0.5	-0.5	-0.5	-0.5	-0.5	-0.5	-0.5	-0.5

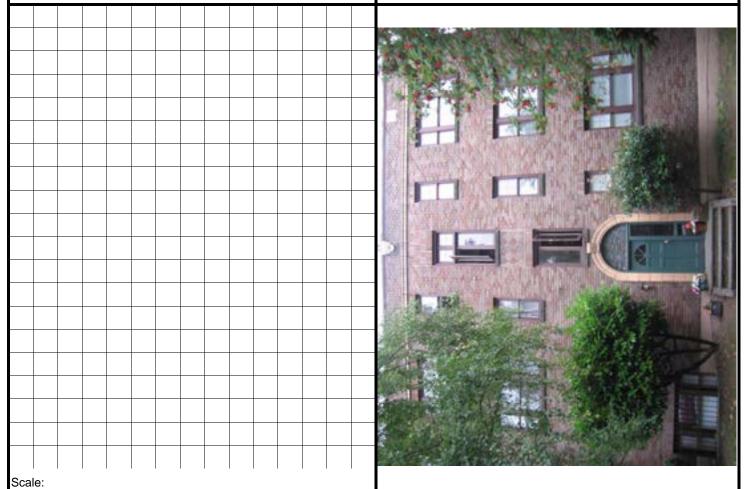
Address	1	719 E Sprin	g St						
District	Capitol Hil	pitol Hill Zip 98122							
Other Identif	iers								
No. Stories	3+bsmt	Year Built	1929						
Inspector -	KMB	Date	08.10.07						
Total Floor A	Area (sq. ft)		10,000						
Building Nan	ne	The Pala	ımar						
Use

OCCUPANCY STRUCTURAL SCORES AND MODIFIERS						RS								
* Residential	No. Persons:	BUILDING TYPE	W	<u>S1</u>	<u>S2</u>	<u>S3</u>	<u>S4</u>	<u>C1</u>	<u>C2</u>	C3/S5	PC1	PC2	RM	<u>URM</u>
Commercial	0-10	Basic Score	4.5	4.5	3.0	5.5	3.5	2.0	3.0	1.5	2.0	1.5	3.0	1.0
Office	* <mark>11-100</mark>	High Rise	N/A	-2.0	-1.0	N/A	-1.0	-1.0	-1.0	-0.5	N/A	-0.5	-1.0	-0.5
Industrial	100+	Poor Condition	-0.5	-0.5	-0.5	-0.5	-0.5	-0.5	-0.5	-0.5	-0.5	-0.5	-0.5	-0.5
Pub. Assem.		Vert. Irregularity	-0.5	-0.5	-0.5	-0.5	-0.5	-1.0	-0.5	-0.5	-1.0	-1.0	-0.5	-0.5
School		Soft Story	-1.0	-2.5	-2.0	-1.0	-2.0	-2.0	-2.0	-1.0	-1.0	-2.0	-2.0	-1.0
Govt. Bldg.		Torsion	-1.0	-2.0	-1.0	-1.0	-1.0	-1.0	-1.0	-1.0	-1.0	-1.0	-1.0	-1.0
Emer. Serv.		Plan Irregularity	-1.0	-0.5	-0.5	-0.5	-0.5	-0.5	-0.5	-0.5	-1.0	-1.0	-1.0	-1.0
Historic Bldg.		Pounding	N/A	-0.5	-0.5	N/A	-0.5	-0.5	N/A	N/A	N/A	-0.5	N/A	N/A
Nonstructura	al	Large Heavy Cladding	N/A	-2.0	N/A	N/A	N/A	-1.0	N/A	N/A	N/A	-1.0	N/A	N/A

Falling Haza	ard X	Short Columns	N/A	N/A	N/A	N/A	N/A	-1.0	-1.0	-1.0	N/A	-1.0	N/A	N/A
		Post Benchmark Year	2.0	2.0	2.0	2.0	2.0	2.0	2.0	N/A	2.0	2.0	2.0	N/A
DATA CON	FIDENCE	SL2	-0.3	-0.3	-0.3	-0.3	-0.3	-0.3	-0.3	-0.3	-0.3	-0.3	-0.3	-0.3

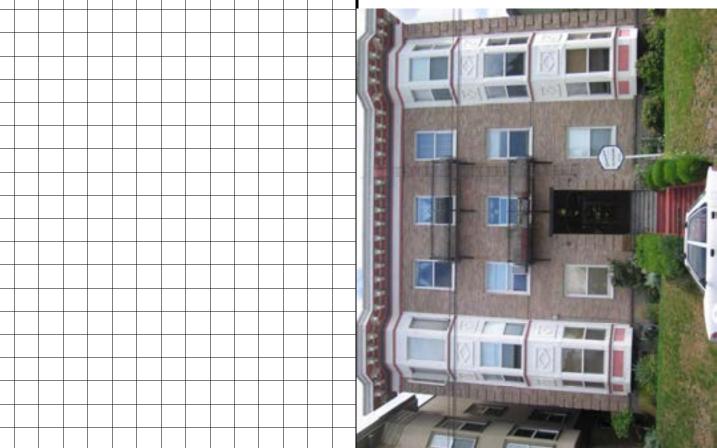
Address	1	726 15th A	ve					
District	Capitol Hill	Capitol Hill Zip 98122						
Other Identif	fiers							
No. Stories	3+bsmt	Year Built	1907					
Inspector	KMB	Date	08.09.07					
Total Floor A	Area (sq. ft)	1	18,158					
Building Nar	ne	The Prince	eton					
Use	<u> </u>

OCCUI	PANCY	STR	UCTU	RAL	SCO	RES	AND	MO	DIFIE	RS				
* Residential	No. Persons:	BUILDING TYPE	W	<u>S1</u>	<u>S2</u>	<u>S3</u>	<u>S4</u>	<u>C1</u>	<u>C2</u>	C3/S5	PC1	PC2	RM	<u>URM</u>
Commercial	0-10	Basic Score	4.5	4.5	3.0	5.5	3.5	2.0	3.0	1.5	2.0	1.5	3.0	1.0
Office	11-100	High Rise	N/A	-2.0	-1.0	N/A	-1.0	-1.0	-1.0	-0.5	N/A	-0.5	-1.0	-0.5
Industrial	* <mark>100+</mark>	Poor Condition	-0.5	-0.5	-0.5	-0.5	-0.5	-0.5	-0.5	-0.5	-0.5	-0.5	-0.5	-0.5
Pub. Assem.		Vert. Irregularity	-0.5	-0.5	-0.5	-0.5	-0.5	-1.0	-0.5	-0.5	-1.0	-1.0	-0.5	-0.5
School		Soft Story	-1.0	-2.5	-2.0	-1.0	-2.0	-2.0	-2.0	-1.0	-1.0	-2.0	-2.0	-1.0
Govt. Bldg.		Torsion	-1.0	-2.0	-1.0	-1.0	-1.0	-1.0	-1.0	-1.0	-1.0	-1.0	-1.0	-1.0
Emer. Serv.		Plan Irregularity	-1.0	-0.5	-0.5	-0.5	-0.5	-0.5	-0.5	-0.5	-1.0	-1.0	-1.0	-1.0
Historic Bldg.		Pounding	N/A	-0.5	-0.5	N/A	-0.5	-0.5	N/A	N/A	N/A	-0.5	N/A	N/A
Nonstructura	al	Large Heavy Cladding	N/A	-2.0	N/A	N/A	N/A	-1.0	N/A	N/A	N/A	-1.0	N/A	N/A

Falling Haza	ard	Short Columns	N/A	N/A	N/A	N/A	N/A	-1.0	-1.0	-1.0	N/A	-1.0	N/A	N/A
		Post Benchmark Year	2.0	2.0	2.0	2.0	2.0	2.0	2.0	N/A	2.0	2.0	2.0	N/A
DATA CON	FIDENCE	SL2	-0.3	-0.3	-0.3	-0.3	-0.3	-0.3	-0.3	-0.3	-0.3	-0.3	-0.3	-0.3

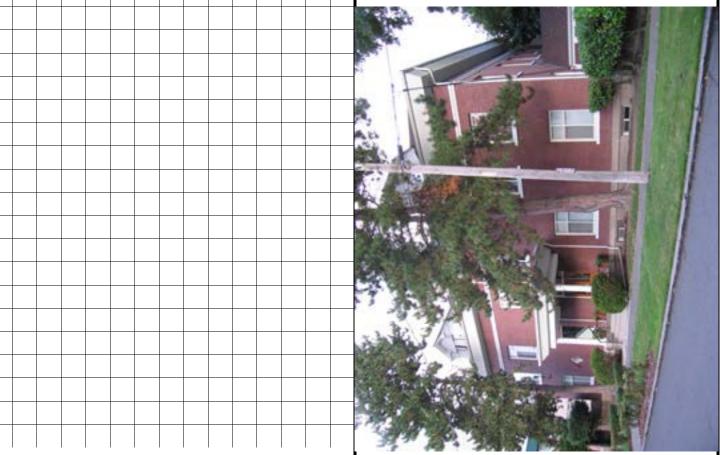
Address	1	808 18th A	ve						
District	Capitol Hill	Capitol Hill Zip 98122							
Other Identif	fiers								
No. Stories	2+bsmt	Year Built	1911						
Inspector	KMB	Date	10.04.07						
Total Floor A	Area (sq. ft)	2	25,200						
Building Nar	ne <b>Un</b>	ion Gospe	Mission						
Use

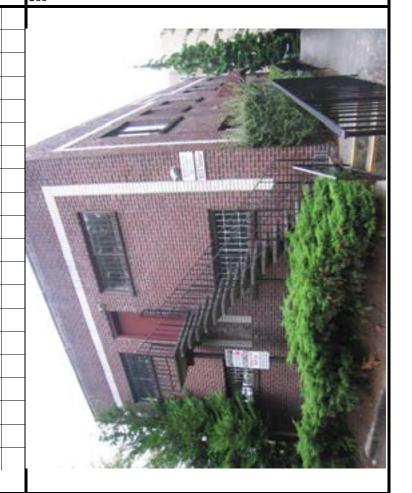
1812 E Madison Address **Capitol Hill** Zip 98122 District Other Identifiers 2+bsmt 1925 No. Stories Year Built 08.10.07 **KMB** Inspector Date Total Floor Area (sq. ft) 6,400 PROSPERO LLC Building Name Use

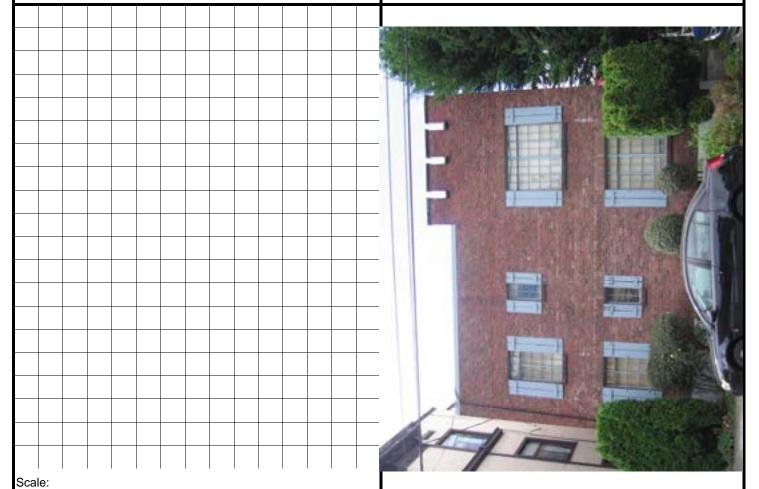
Address	1	815 15th A	ve
District	Capitol Hill	Zip	98122
Other Identifiers	S		
No. Stories	2+bsmt	Year Built	1929
Inspector	KMB	Date	08.09.07
Total Floor Area	a (sq. ft)	1	2,828
Building Name	L	ansdowne	Manor
Use

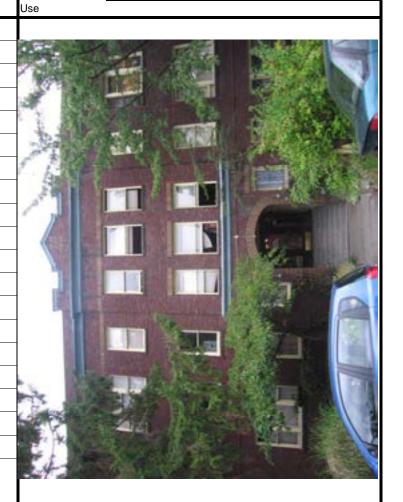
1818 20th Ave Address **Capitol Hill** 98122 District Zip Other Identifiers 3+bsmt 1927 No. Stories Year Built 08.10.07 **KMB** Inspector Date Total Floor Area (sq. ft) 22,000 **Prince of Wales Apartment** Building Name

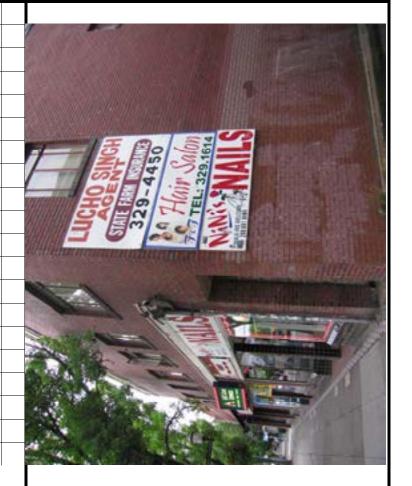
1824 to 1828 Broadway E Address Capitol Hill 98102 Zip District Other Identifiers 2 No. Stories Year Built KMB 08.03.07 Inspector Date Total Floor Area (sq. ft) Nini's Nails Building Name

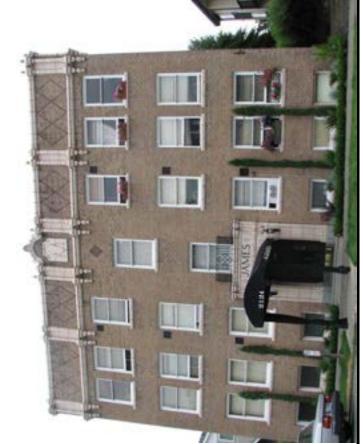
2124 California Ave SW Address West Seattle 98116 Zip District Other Identifiers 3+ 1928 No. Stories Year Built KMB 07.17.07 Inspector Date Total Floor Area (sq. ft) 17,810 **The James Apartments** Building Name Use

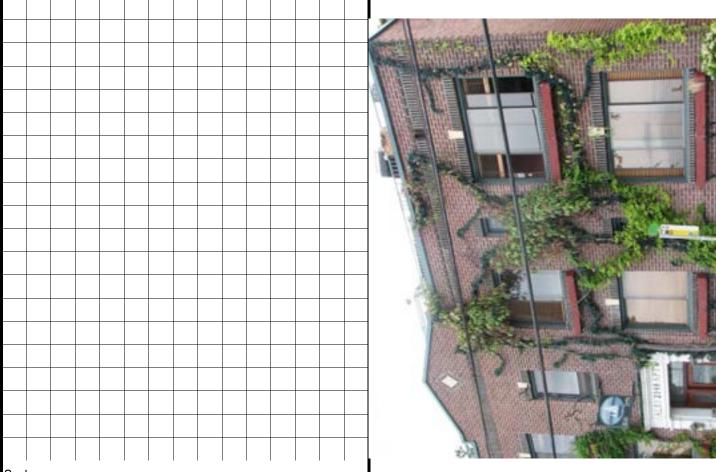
Address	234	48 Alki Ave	SW					
District	West Seattle	Zip	98116					
Other Identifier	S							
No. Stories	2+bsmt	Year Built	1928					
Inspector	KMB	Date	07.13.07					
Total Floor Are	a (sq. ft)	15,687						
Building Name		Alki Apartı	ments					
عوا ا		-

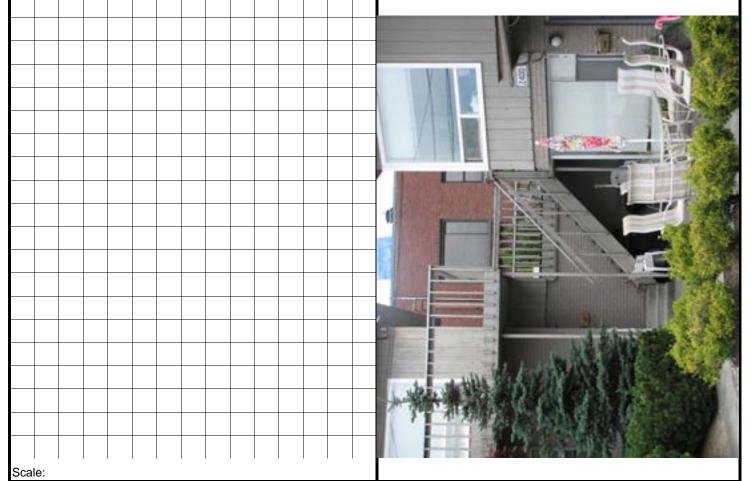
Address	23	52 Alki Ave	SW
District	West Seattle	Zip	98116
Other Identifier	rs		
No. Stories	2	Year Built	1901
Inspector	KMB	Date	07.13.07
Total Floor Are	ea (sq. ft)		4,524
<b>Building Name</b>	Th	e Tides Ap	artments
Use

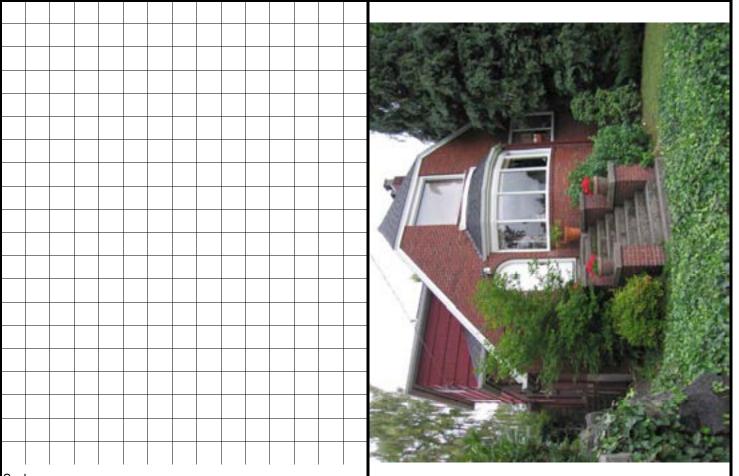
Address	2	506 N 42nd	St
District	University	Zip	98105
Other Identifiers			
No. Stories	2	Year Built	1929
Inspector	KMB	Date	09.20.07
Total Floor Area	(sq. ft)		1,607
Building Name			
Use	R	esidential

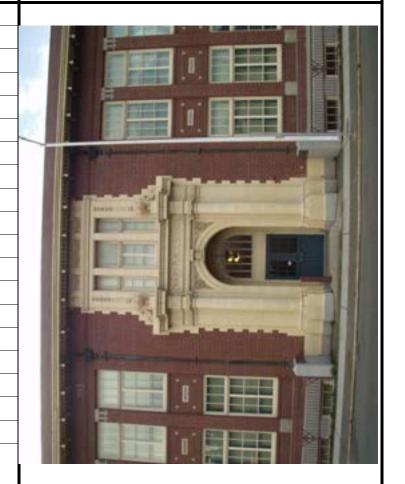
2515 Boylston Ave E Address Capitol Hill 98102 Zip District Other Identifiers 3 1917 No. Stories Year Built 09.28.07 ADF Inspector Date 29,660 Total Floor Area (sq. ft) **Seward Elementary School** Building Name

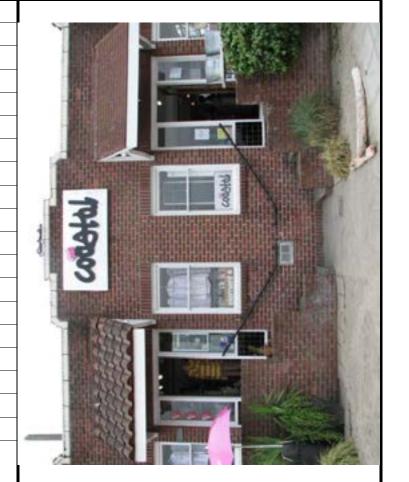
2530 Alki Ave SW Address West Seattle 98116 Zip District Other Identifiers 1 1930 No. Stories Year Built KMB 07.13.07 Inspector Date Total Floor Area (sq. ft) 5,880 Coastal Building Name Use

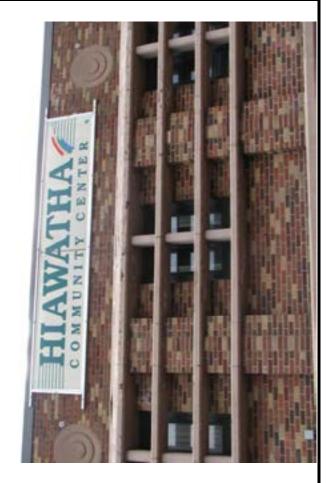
2700 California Ave SW Address West Seattle 98116 Zip District Other Identifiers 2 1915 No. Stories Year Built KMB 07.17.07 Inspector Date 9,761 Total Floor Area (sq. ft) **Hiawatha Community Center** Building Name

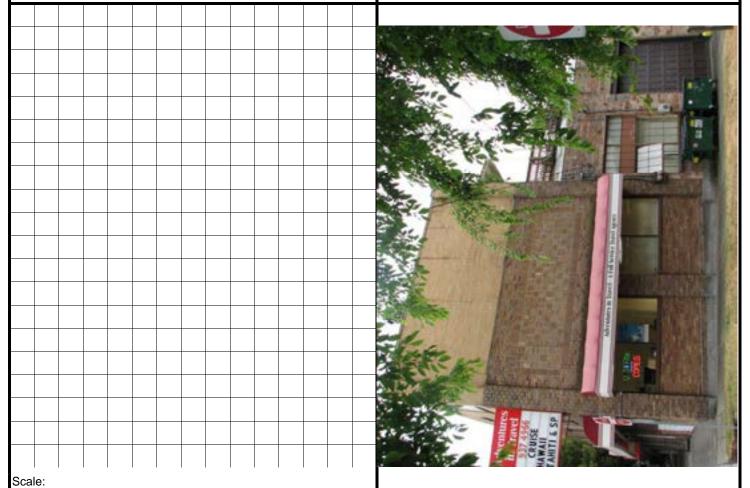
Address	27	'01 California A	ve SW
District	West Sea	<b>ittle</b> Zip	98116
Other Identif	iers		
No. Stories	3	Year Built	1930
Inspector	KMB	Date	07.17.07
Total Floor A	rea (sq. ft)	8	3,400
Building Nan	ne	Admiral Jur	nction
Use

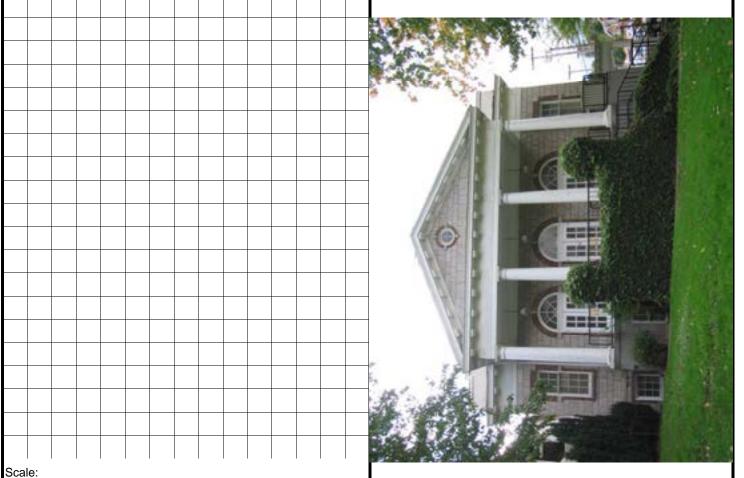
Address	3	3515 S Alask	a St
District	Columbia C		98118
Other Identifier	rs		
No. Stories	2	Year Built	1921
Inspector	KMB	Date	10.04.07
Total Floor Are	ea (sq. ft)		8,836
Building Name	Rain	ier Valley Yo	uth Theater
Use

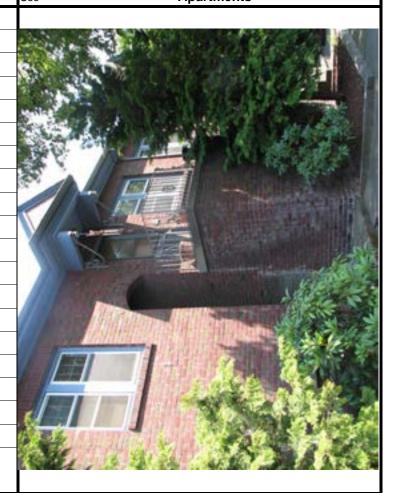
Address	3600	California <i>A</i>	Ave SW
District	West Seattle	Zip	98116
Other Identif	iers		
No. Stories	2+bsmt	Year Built	1928
Inspector	KMB	Date	07.12.07
Total Floor A	rea (sq. ft)		6,414
Building Nan	ne		
l Ise	Δr	nartments

Cracking in stair wall

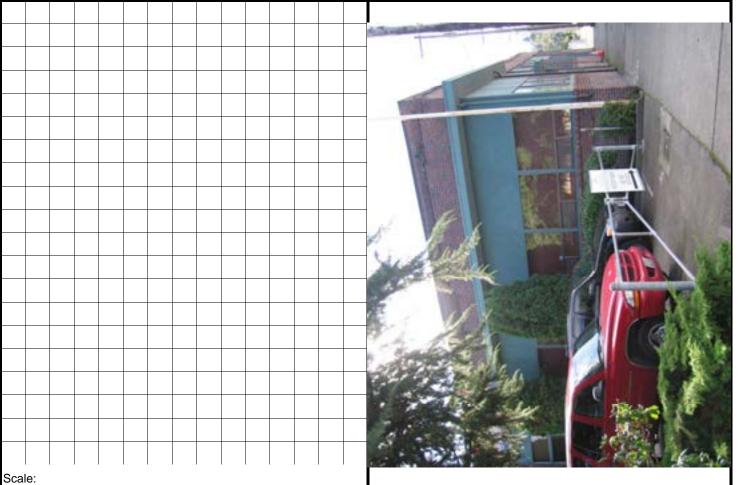
Address	3	3711 S Hudso	n St
District	Columbia C	ity Zip	98118
Other Identifie	rs		
No. Stories	1+bsmt	Year Built	1920
Inspector	KMB	Date	10.04.07
Total Floor Are	ea (sq. ft)	1	4,000
Building Name	Saint G	obain Perfor	mance Plastics
Use

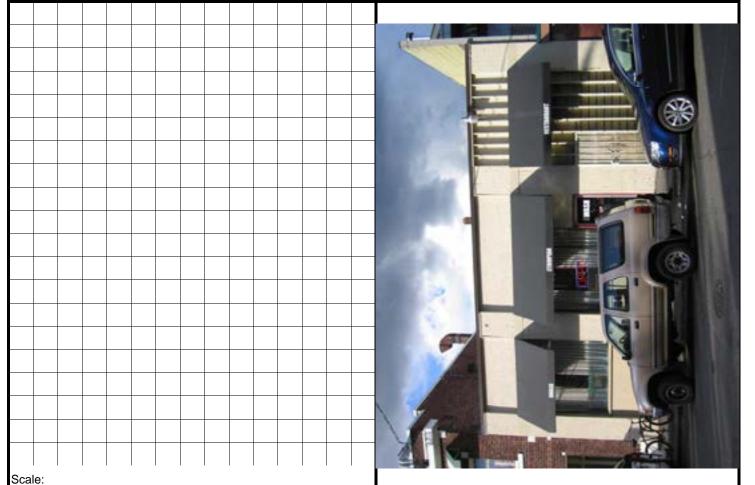
Address	38	308 S Edmun	ds St
District	Columbia C	ity Zip	98118
Other Identifie	rs		
No. Stories	1	Year Built	1925
Inspector	KMB	Date	10.04.07
Total Floor Are	ea (sq. ft)		
Building Name			
معا ا

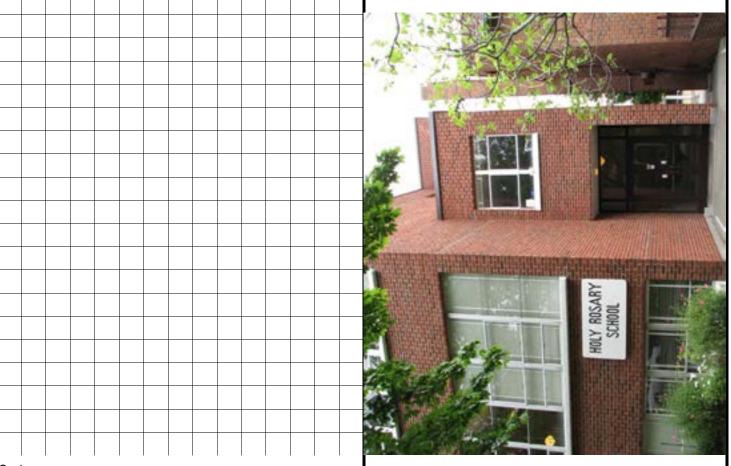
Address	414	2 42nd Av	e SW
District	West Seattle	Zip	98116
Other Identifier	rs	<u> </u>	
No. Stories	3	Year Built	1922
Inspector	KMB	Date	07.11.07
Total Floor Are	ea (sq. ft)	3	33,460
<b>Building Name</b>	Н	oly Rosary	School
Use

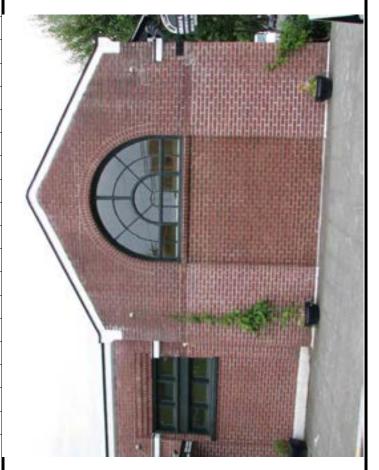
Address	4400 (	California <i>I</i>	Ave SW
District	West Seattle	Zip	98116
Other Identifiers	S		
No. Stories	2	Year Built	1910
Inspector	KMB	Date	07.11.07
Total Floor Area	a (sq. ft)		2,258
Building Name	Denti	stry and O	rthodontics
Use		-

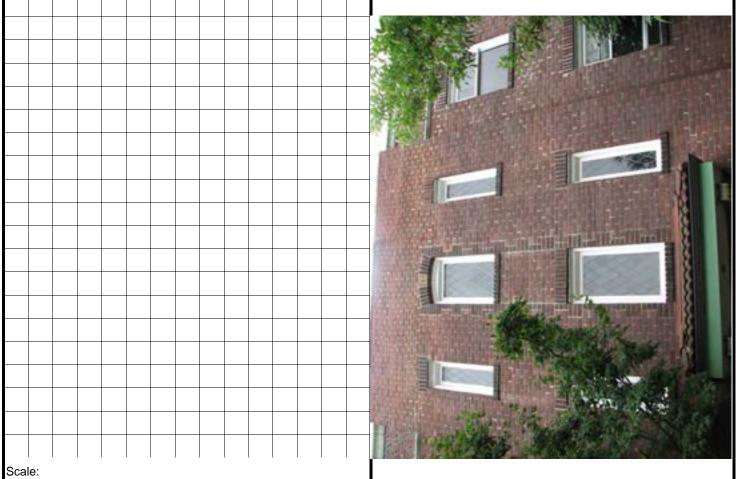
Address	44	03 SW Admir	al Way
District	West Seat	t <b>le</b> Zip	98116
Other Identifiers	3		
No. Stories	3	Year Built	1928
Inspector	KMB	Date	07.17.07
Total Floor Area	a (sq. ft)		8,705
Building Name	Th	e Nelsonian A	Apartments
Use

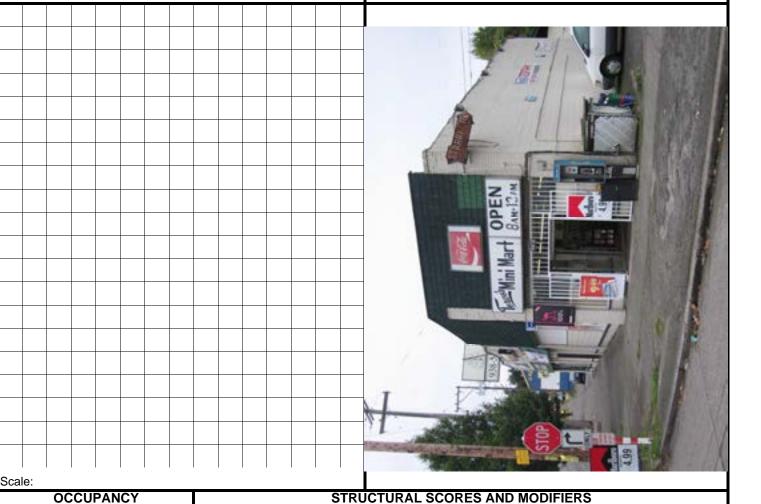
Address	44	15 to 442	1 Fauntle	eroy Way SW
District	Wes	t Seattle	Zip	98126
Other Identif	fiers			
No. Stories	1	,	Year Built	1924
Inspector	KN	IB	Date	10.04.07
Total Floor A	Area (sq. ft)			3,793
Building Nar	me _	T	ervo's M	ini Mart
Lloo

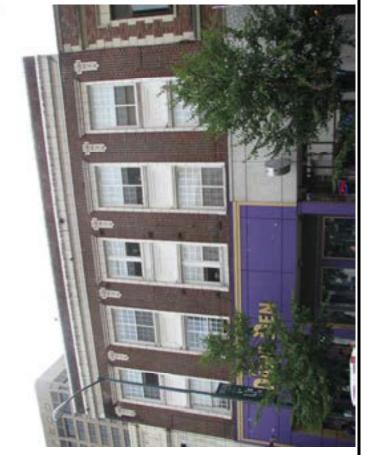
4509 to 4513 University Way Address University 98105 Zip District Other Identifiers 3 1916 No. Stories Year Built 07.17.07 **KMB** Inspector Date Total Floor Area (sq. ft) 18,967 Building Name Dawg Den Use

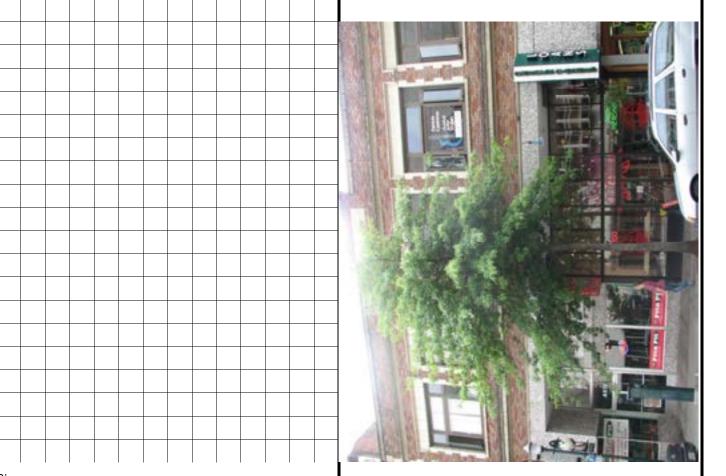
Address		4515-4519 University Way									
District	Univ	rsity Zip 98105									
Other Identi	fiers										
No. Stories	2	Yea	r Built	1928							
Inspector	KME	B Dat	е	07.17.07	Ī						
Total Floor	Area (sq. ft)			20,760							
Building Nar	me		Kalbe	rg	1						
عوا ا					٦

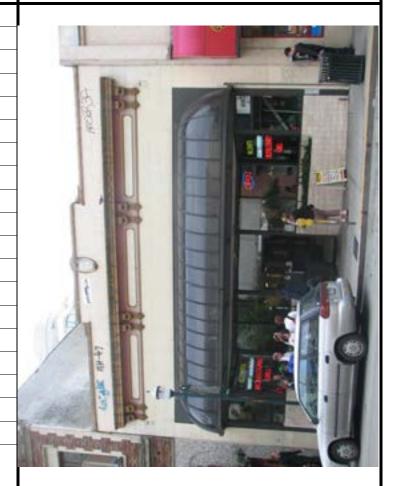
4523 University Way Address University 98105 Zip District Other Identifiers 1924 1 No. Stories Year Built 07.17.07 **KMB** Inspector Date Total Floor Area (sq. ft) 4,120 Mongolian Grill Building Name Use

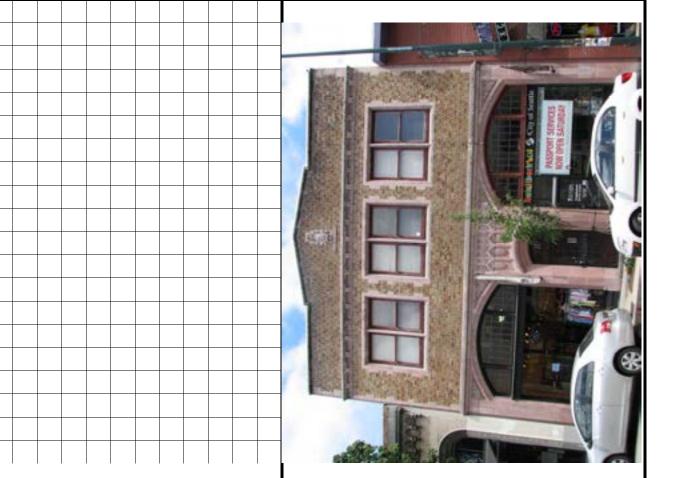
Address	4534 to	4534 to 4536 University Way							
District	University	Zip	98105						
Other Identifiers									
No. Stories	2	Year Built	1927						
Inspector	KMB	Date	07.13.07						
Total Floor Area	(sq. ft)		8,284						
Building Name		Gelb Buil	ding						
ا ادو

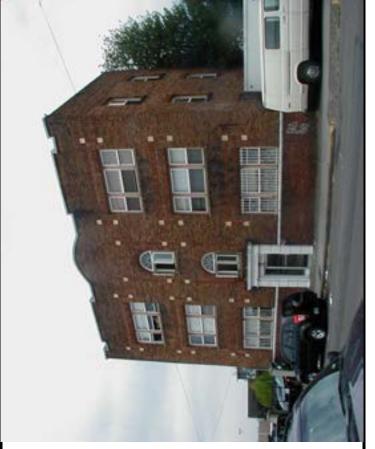
Address	4541	Brooklyn A	Ave NE
District	University	Zip	98105
Other Identifiers	3		
No. Stories	3	Year Built	1927
Inspector	ADF	Date	07.12.07
Total Floor Area	a (sq. ft)		9,504
Building Name			
Use
