# Unreinforced Masonry Building Seismic Hazards Study

December 2007

City of Seattle Department of Planning and Develpoment

Reid Middleton

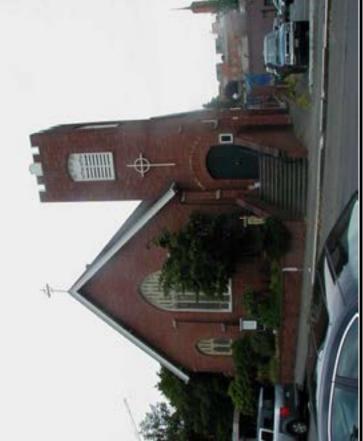
Address	4548	Brooklyn <i>A</i>	Ave NE
District	University	Zip	98105
Other Identifier	S		
No. Stories	1	Year Built	1928
Inspector	ADF	 Date	07.12.07
Total Floor Are	a (sq. ft)	1	0,176
Building Name	Unive	rsity Episc	opal Church
Use		Church

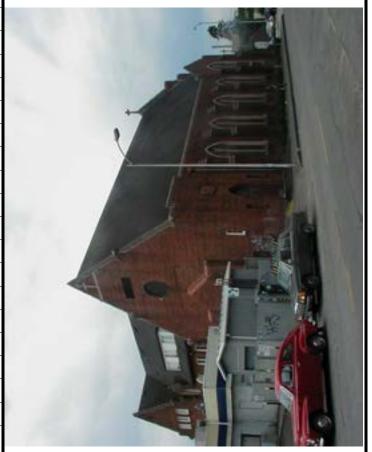
Address	ess 4554 12th Ave NE												
District	University	Zip	98105										
Other Identifiers	;												
No. Stories	3	Year Built	1938										
Inspector	ADF	 Date	07.12.07										
Total Floor Area	ı (sq. ft)	3	0,994										
Building Name													
Use		Church

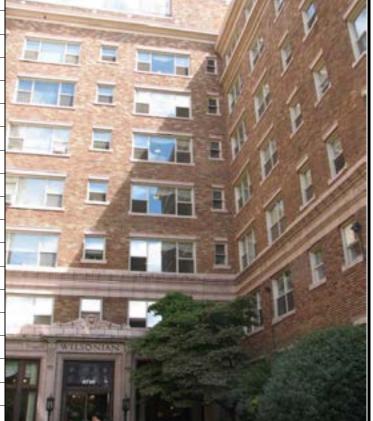
#### 4710 University Way **Reid Middleton** Address **Rapid Visual Screening** University Zip District 728 134th Street SW - Suite 200 of Seismically Other Identifiers **Hazardous Buildings** Everett, Washington 98204 No. Stories Year Built **KMB** Ph: 425 741-3800 Inspector Date **High Seismicity Area** Total Floor Area (sq. ft) 100,234 Fax: 425 741-3900 Wilsonian Building Name Use

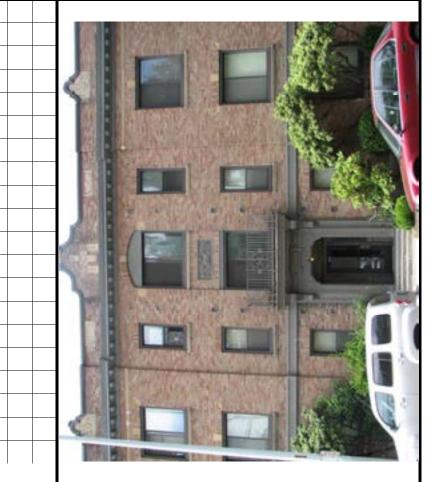
5003 15th Ave NE Address University 98105 Zip District Other Identifiers 3+ 1926 No. Stories Year Built KMB 07.13.07 Inspector Date Total Floor Area (sq. ft) 22,018 **Davison Apartments** Building Name Use

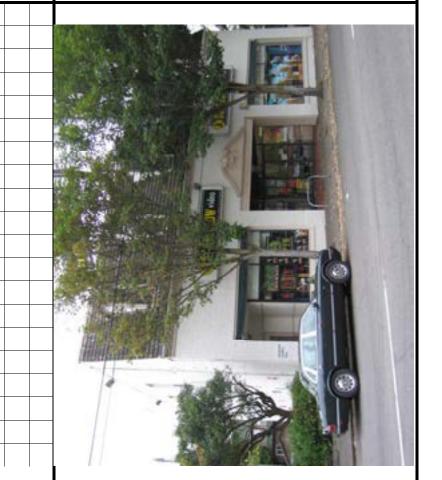
Address	5030	Roosevelt V	Nay NE
District	University	Zip	98115
Other Identifiers			
No. Stories	2	Year Built	1937
Inspector	KMB	Date	09.20.07
Total Floor Area	(sq. ft)	1	3,860
Building Name	Se	eavest Mana	agement
Llaa

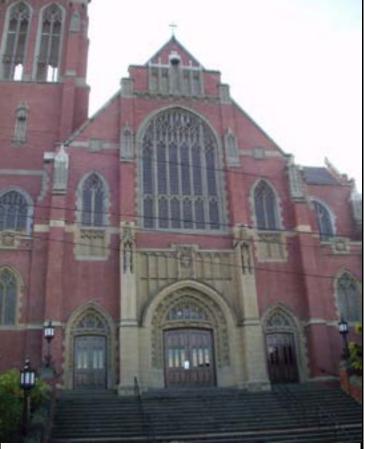
I	E /	0.44 O4b A.va	NE
Address	5(	041 9th Ave	NE
District	University	Zip	98105
Other Identifiers	1		
No. Stories	1	Year Built	1910
Inspector	ADF	Date	10.01.07
Total Floor Area	(sq. ft)	1	6,268
Building Name	Bless	sed Sacram	ent Church
Use

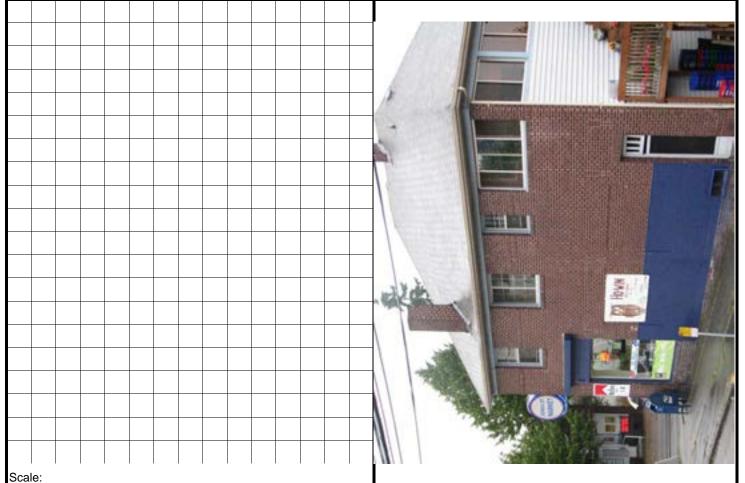
5901 California Ave SW Address West Seattle 98116 Zip District Other Identifiers 2 1926 No. Stories Year Built **KMB** 07.18.07 Inspector Date Total Floor Area (sq. ft) 3,183 Juneau Street Market Building Name Use

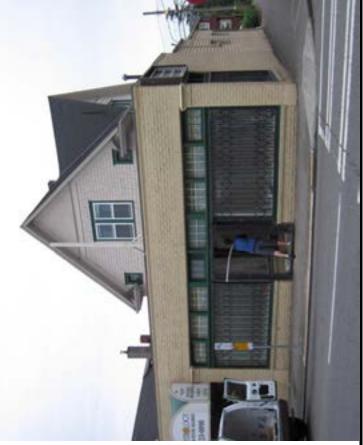
Address	6319	Roosevelt V	Nay NE
District	University	Zip	98115
Other Identifiers	<u> </u>		
No. Stories	1	Year Built	1925
Inspector	KMB	 Date	09.20.07
Total Floor Area	a (sq. ft)		4,330
Building Name	Tr	ne Landing	Records
Use

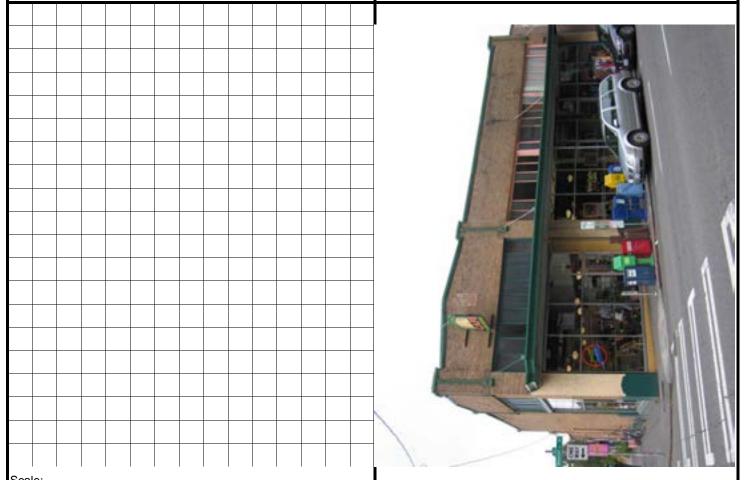
6403 Roosevelt Way NE Address University 98115 Zip District Other Identifiers 1929 1 No. Stories Year Built **KMB** 09.20.07 Inspector Date Total Floor Area (sq. ft) 9,094 Sunlight Café Building Name Use

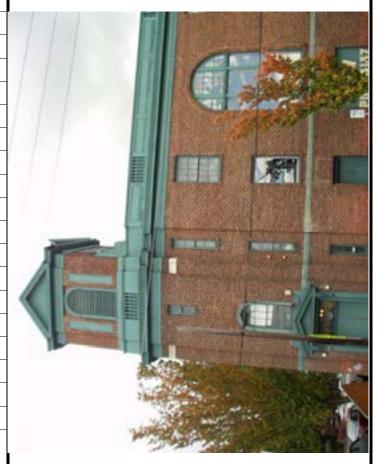
Address	7220 Woodlawn Ave NE						
District	Uni	versity	sity Zip 9811				
Other Identif	iers						
No. Stories	3		Year Built	1921			
nspector	AD	F	Date	09.28.07			
Total Floor A	Area (sq. ft)	rea (sq. ft) 13,056					
Building Nan	me	VFW 4137					
Jse					·

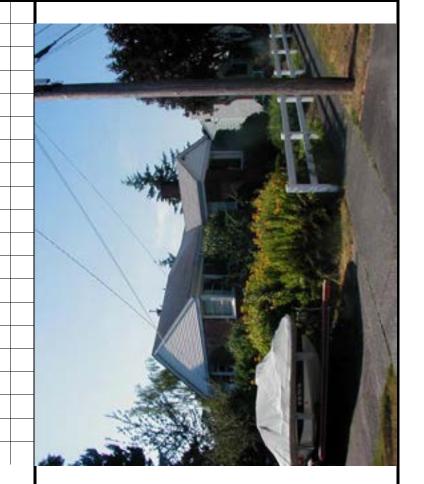
Address	12235 Phinney Ave N					
District	North Seatt	t <b>le</b> Zip	98133			
Other Identifie	ers					
No. Stories	2	2 Year Built				
Inspector	ADF	Date	07.12.07			
Total Floor Ar	ea (sq. ft)		1,870			
Building Name	e					
Use
